Photo Documentation Log

Selecto Flash, Inc. Site

Photo 1. June 1, 2012 – Selecto Flash, Inc.(the Site), is located on Central Avenue in West Orange, New Jersey. The Site was used for large-scale commercial silk screening. A Removal Assessment was performed by Weston Solutions, Inc., Removal Support Team 2 (RST 2), on June 1, 2012.

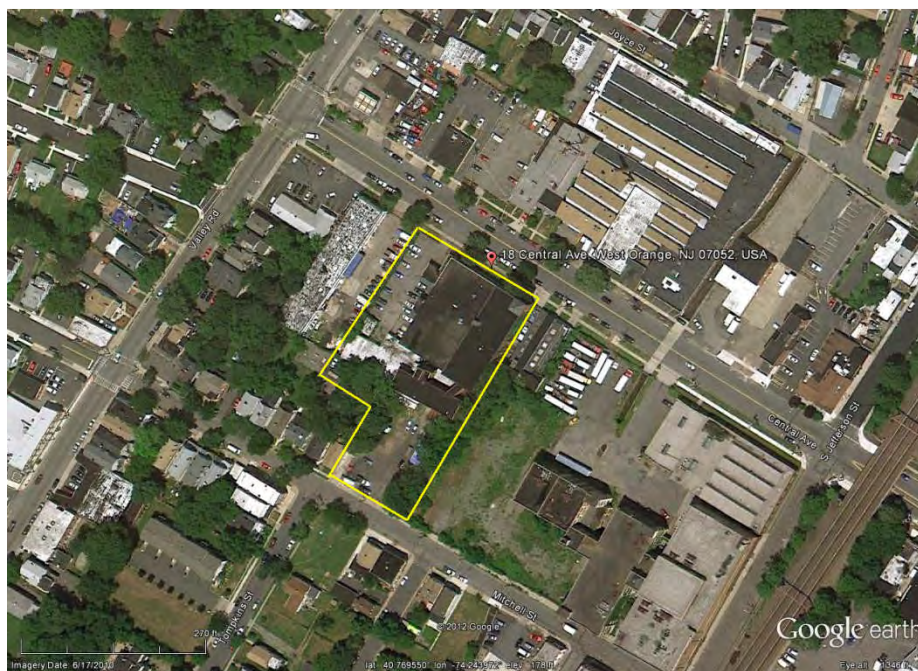
Photo 2. June 1, 2012 – Land use surrounding the Site includes industrial, commercial, and residential properties.

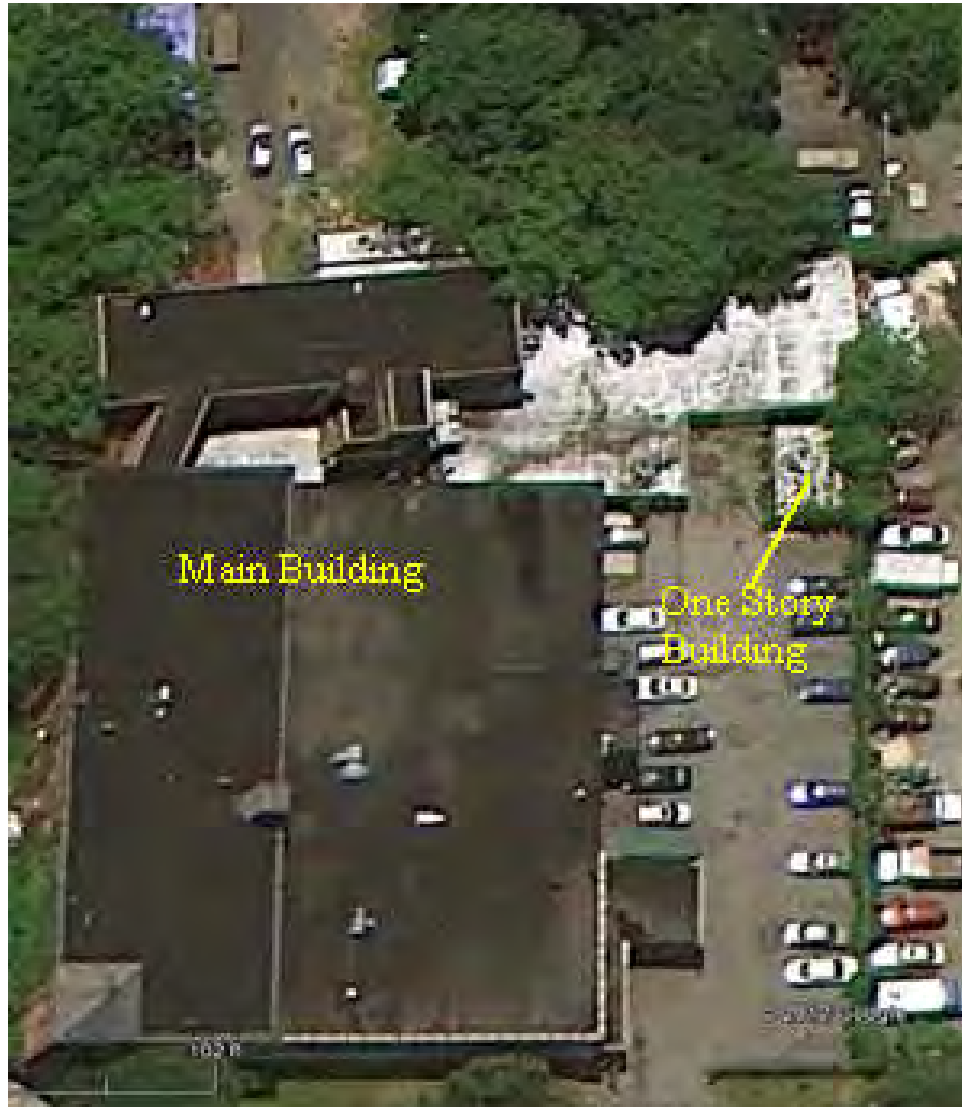
Photo 3. The Site includes a main three-story building and a smaller one-story building. The main building housed all of the industrial operations of the facility.

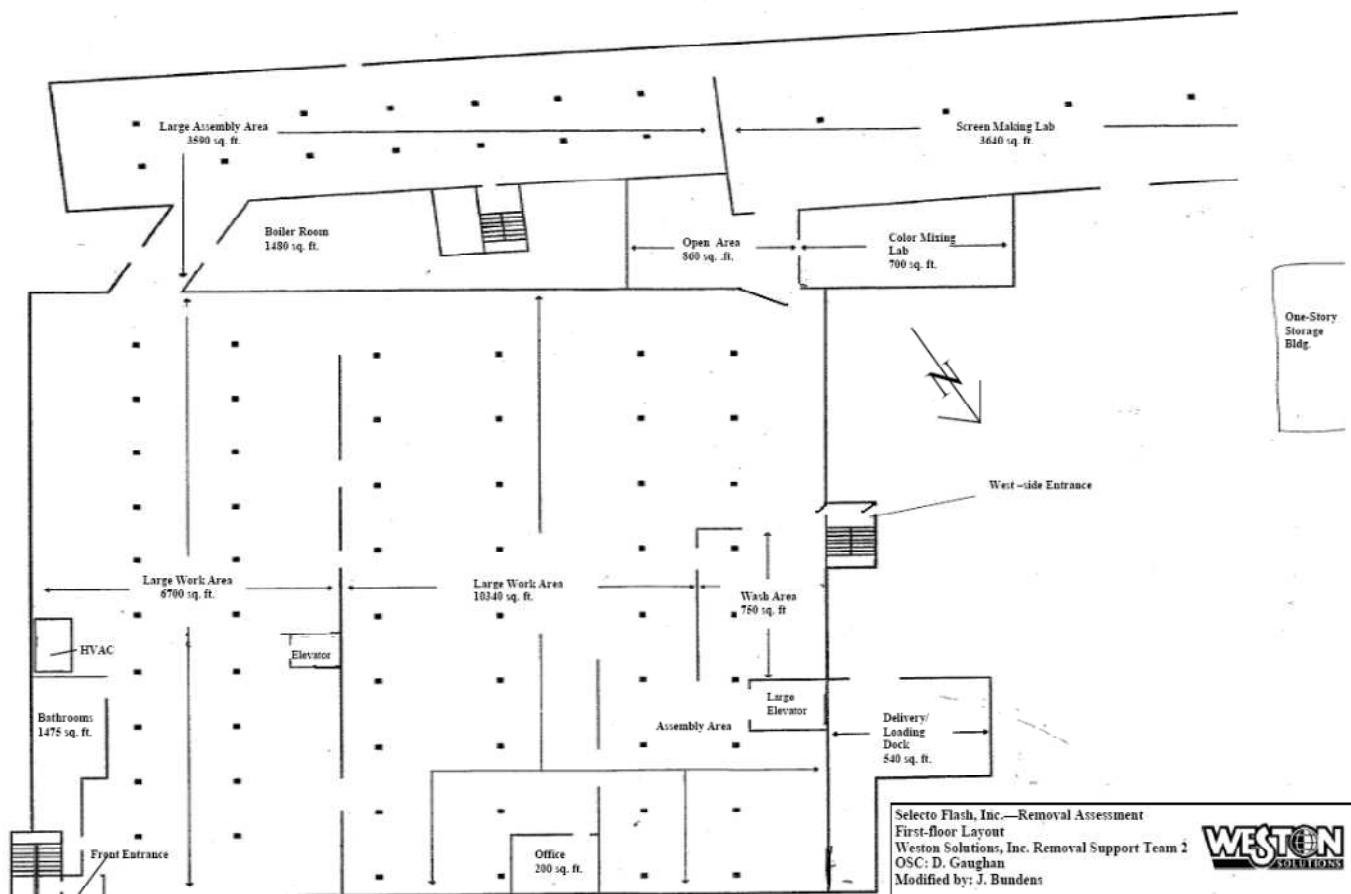
Photo 4. June 1, 2012 - The first-floor was used for staging and UV ink processing. There are large work and assembly areas on this floor. The southern wing of the facility contained the UV screen making lab as well as color mixing lab. To the west side there is a wash station which used chemical solutions in the process.

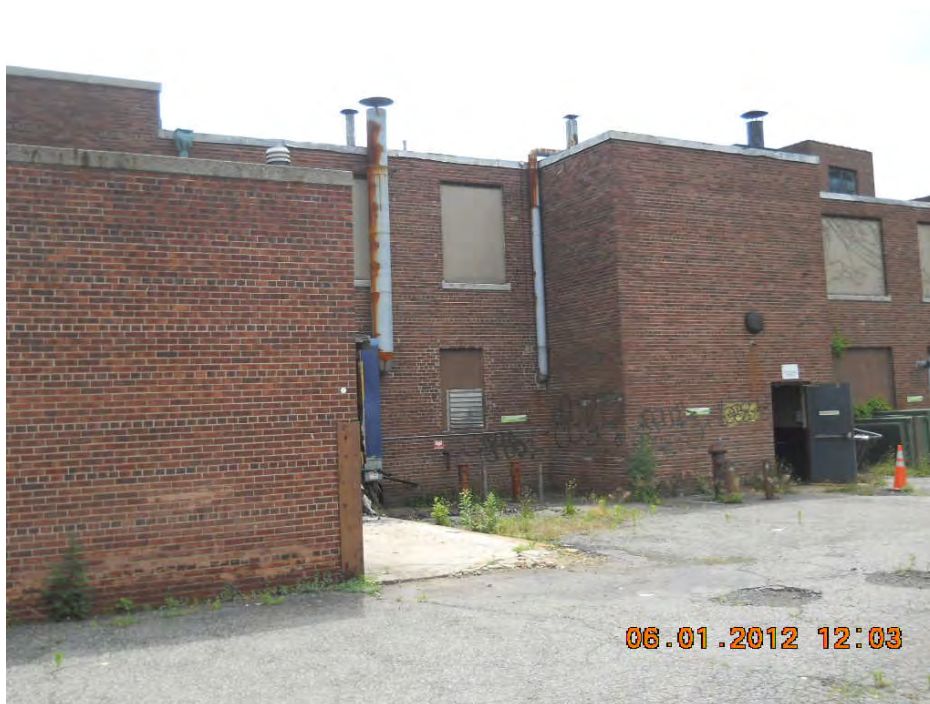
Photo 5. June 1, 2012 – RST 2 entered through the west-side entrance.

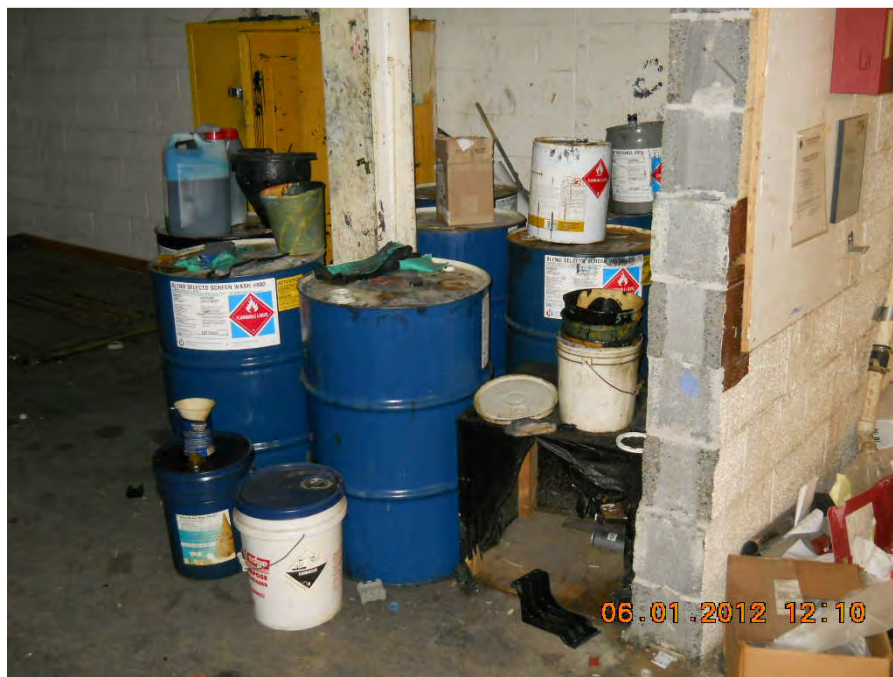
Photo 6. June 1, 2012 – Site inventory began in the wash station. Several 55-gallon drums, smaller metal containers and several ten-liter ink containers were identified.

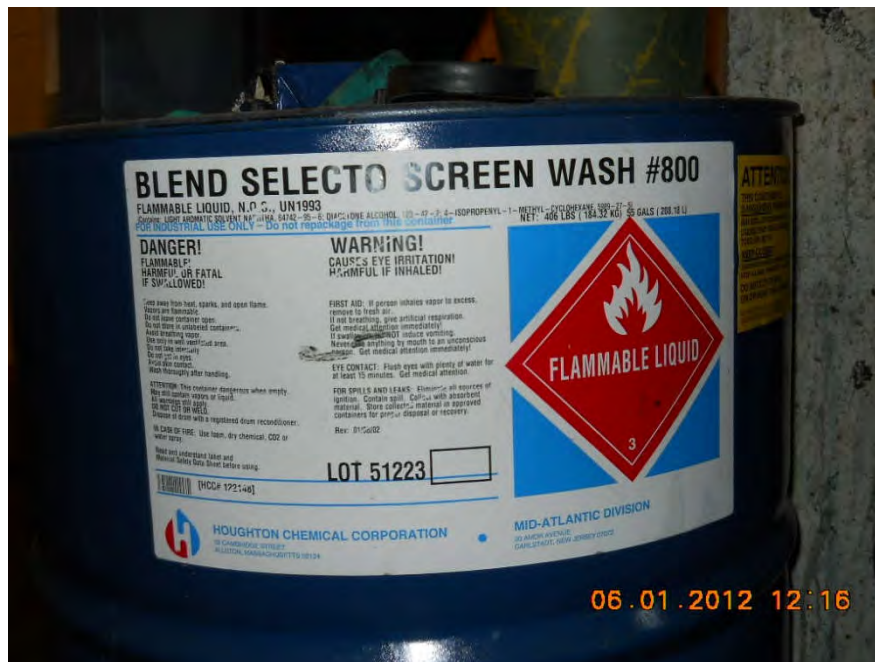
Photo 7. June 1, 2012 - The 55-gallon drums are believed to contain “Blend Selecto Screen Wash #800” as indicated by the label which contains; naptha petroleum solvent, diacetone alcohol, 4-isopropenyl-1-methyl cyclohexene, 1,2,4-trimethylbenzene, and xylene.

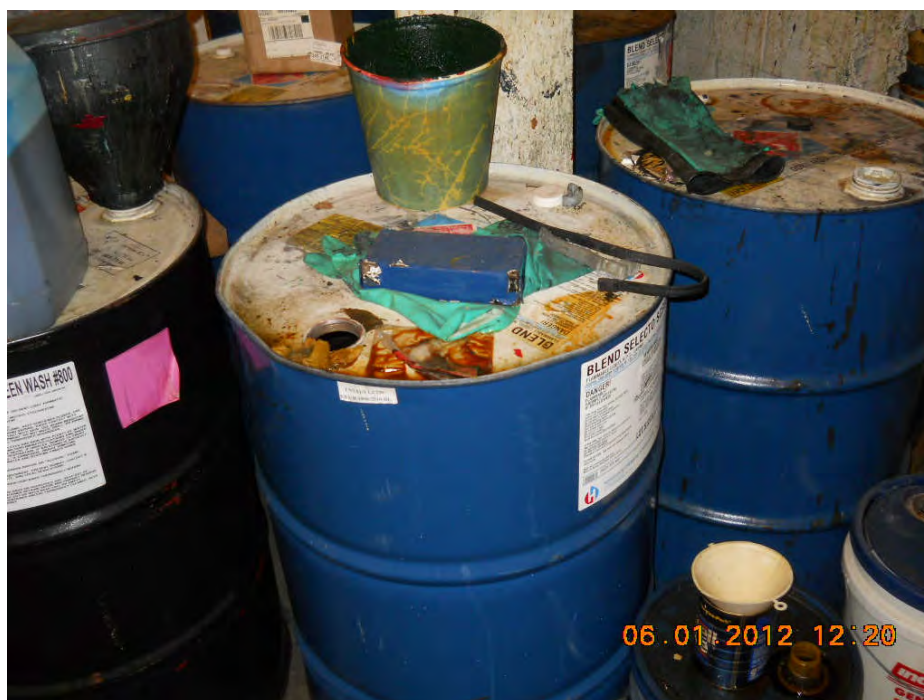
Photo 8. June 1, 2012 – One of the 55-gallon drums was open, giving a reading of 1,500 ppm as indicated on the MultiRae.

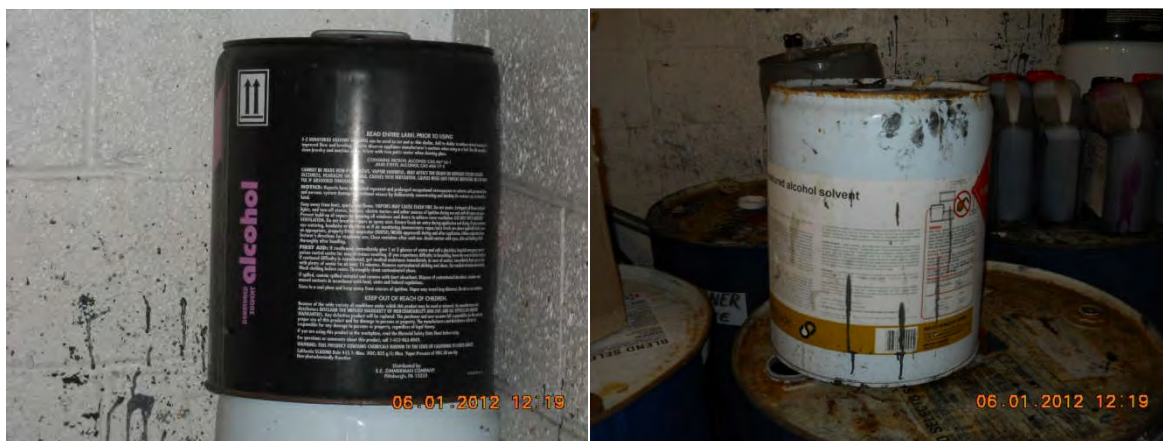
Photo 9. June 1, 2012 – Cans of denatured alcohol solvent were also found, as well as ten-liter containers of solvent ink.

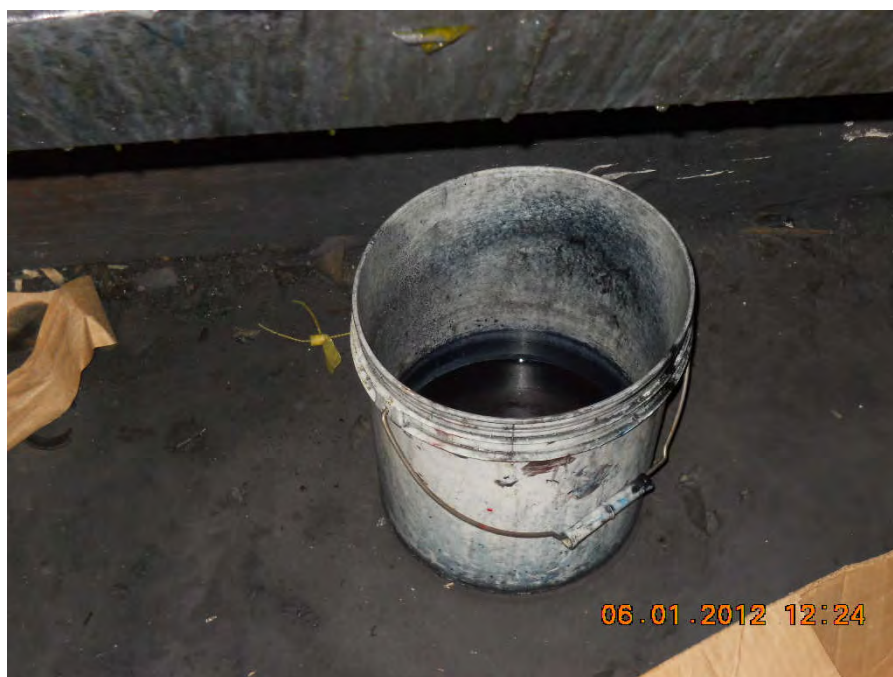
Photo 10. June 1, 2012 – A five-gallon bucket of an exposed oil-looking substance was found under the chemical wash basin giving a reading of 212 ppm with the MultiRae.

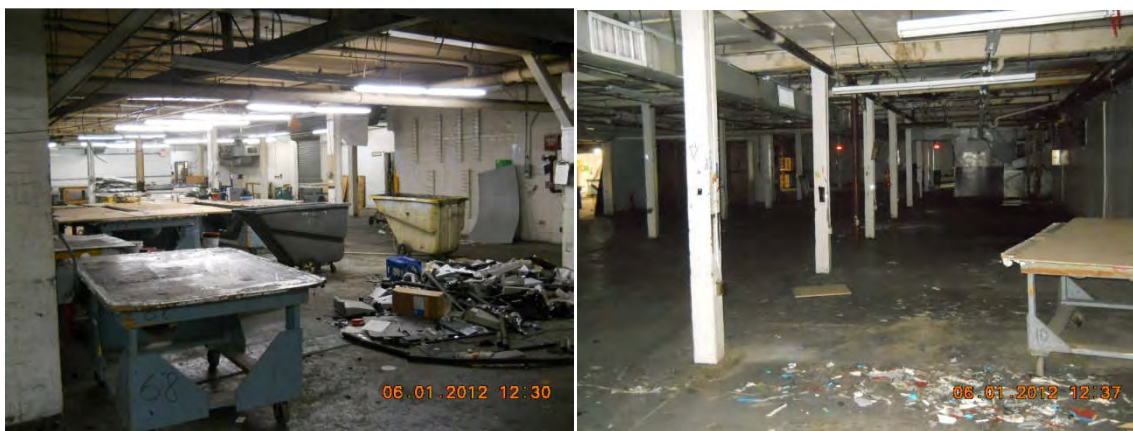
Photo 11. June 1, 2012 – Large open spaces and assembly areas provided adequate workspace for this large commercial facility.

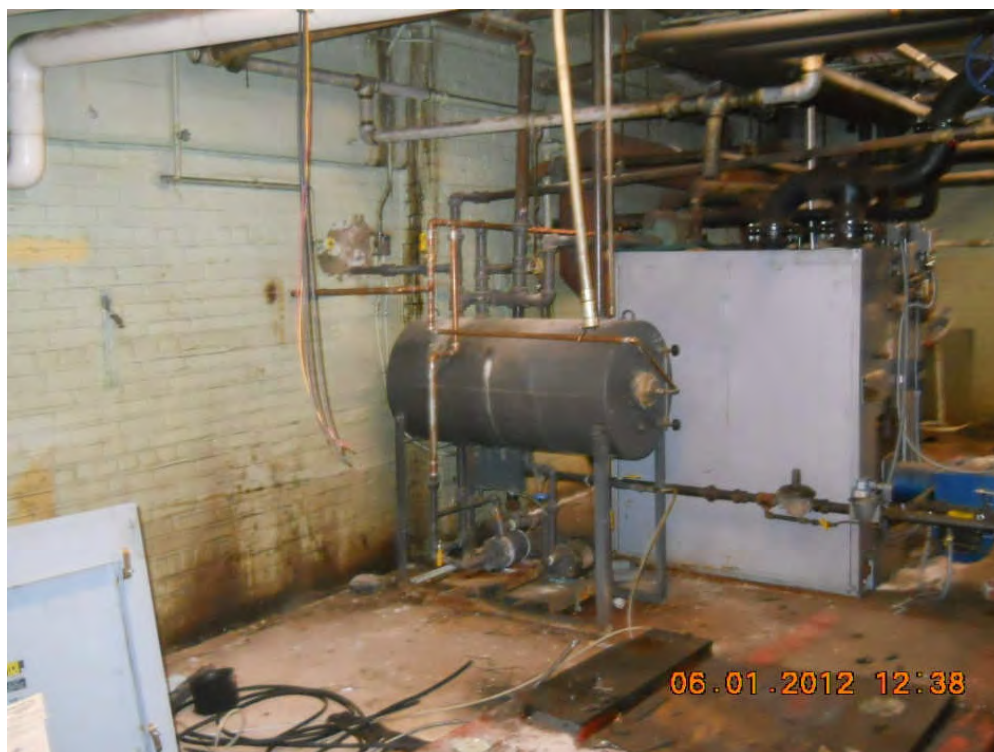
Photo 12. June 1, 2012 – Large boiler room located at the southern end of the facility.

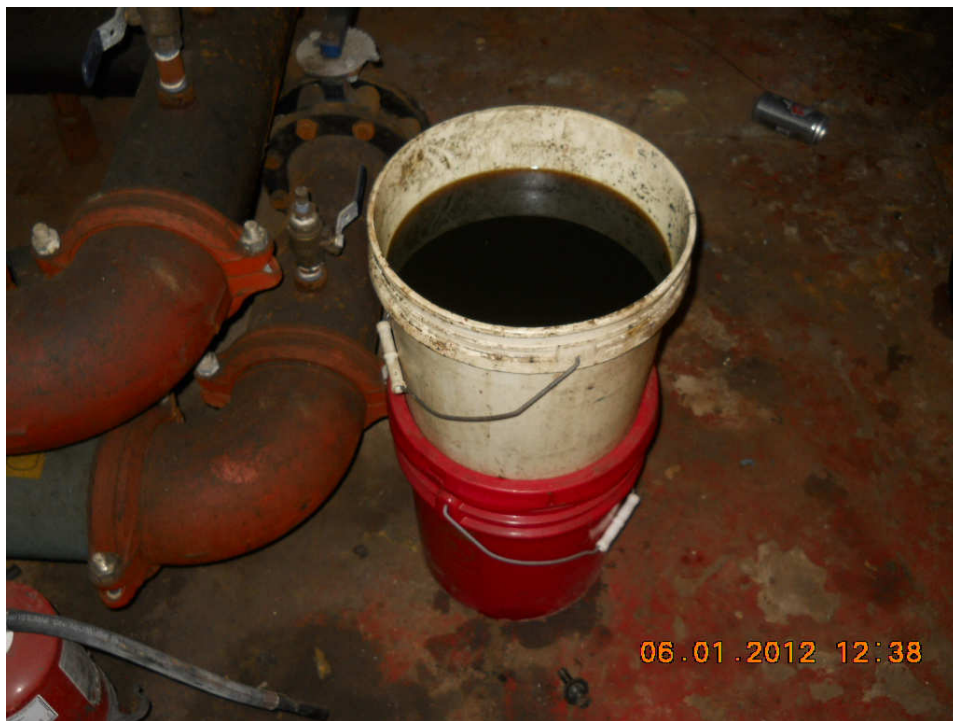
Photo 13. A five-gallon bucket containing an exposed oil-looking substance. There were no readings as indicated from the MultiRae.

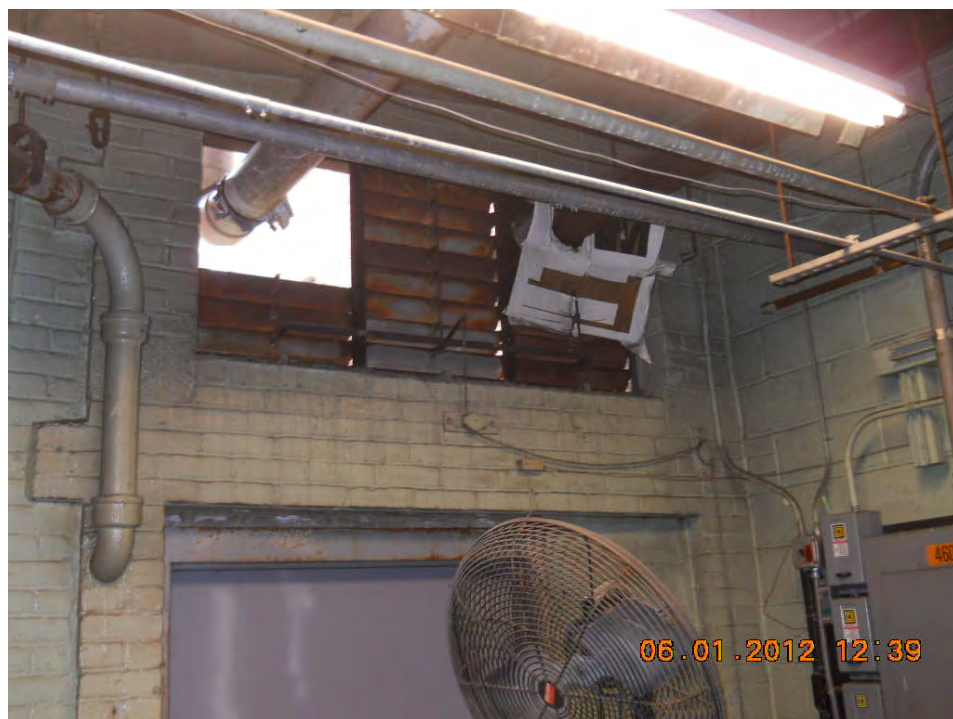
Photo 14. June 1, 2012 – Broken window panel in boiler room.

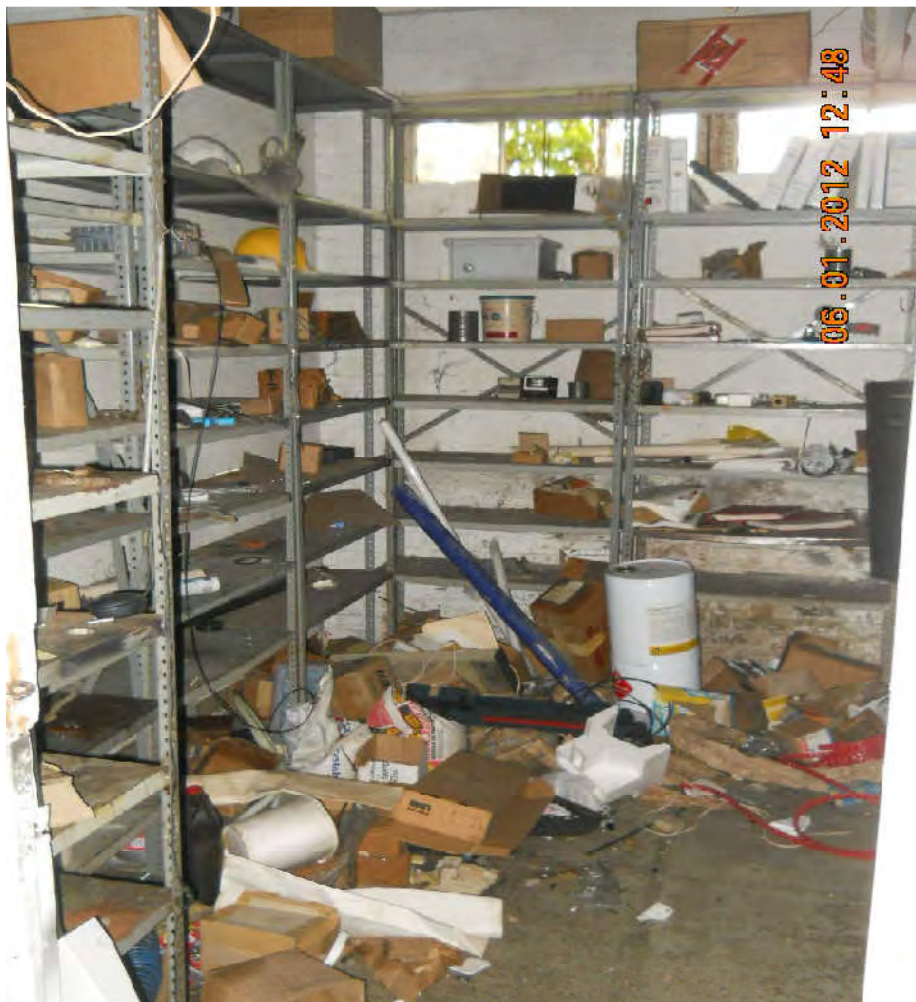
Photo 15. June 1, 2012 – Storage areas in the southern wing containing various items of minor concern.

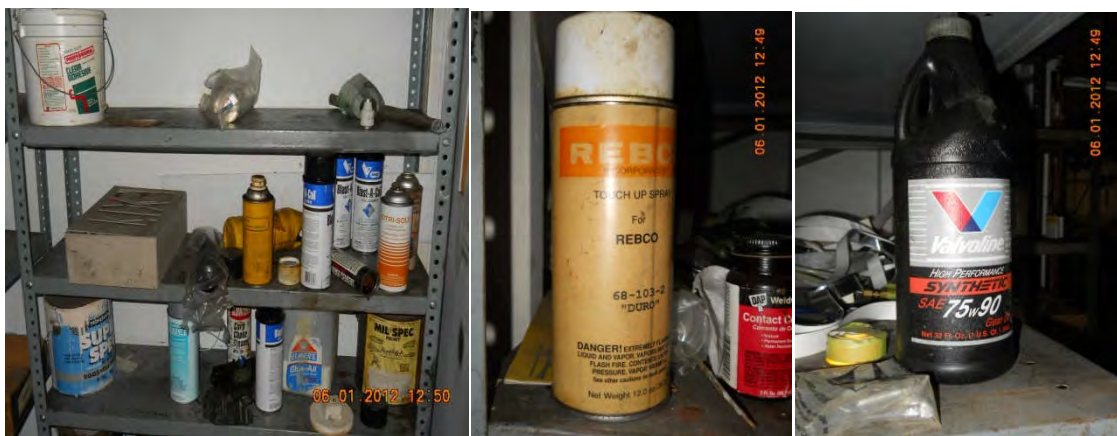
Photo 16. June 1, 2012 – Items found in these storage areas included motor oil and various degreasing/cleaning substances.

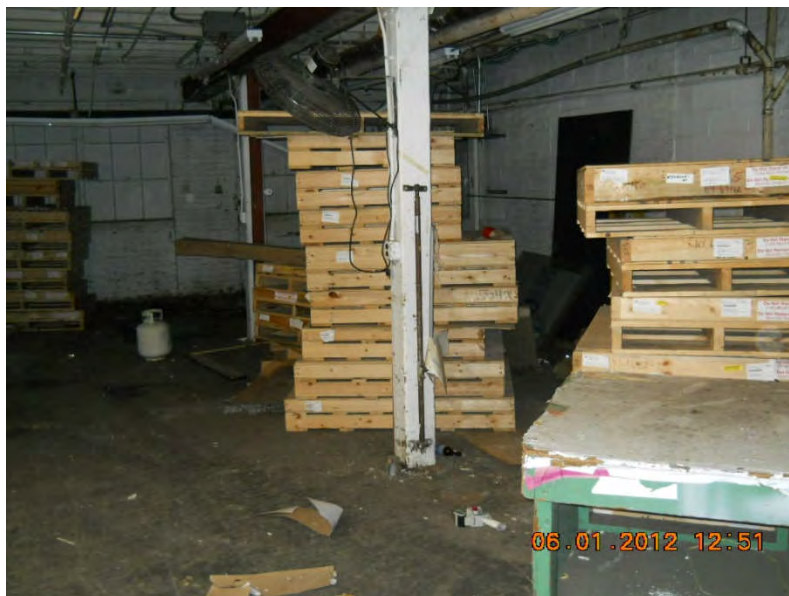
Photo 17. June 1, 2012 – Large assembly area in the southern wing. This area contained several tanks of various sizes and substances.

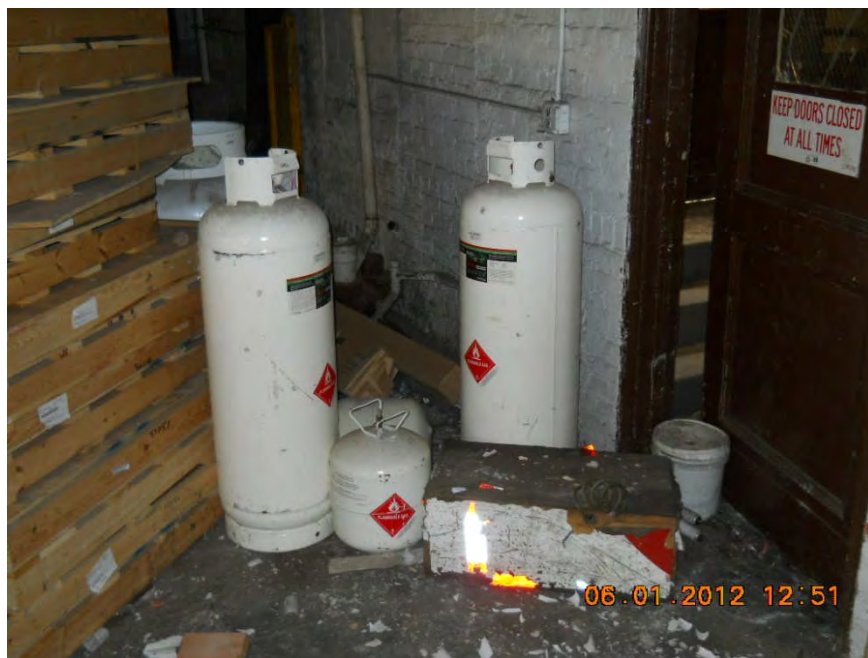
Photo 18. June 1, 2012 – Two small and two large cylindrical tanks were identified, labeled “Premier Adhesive” which contains methylene chloride, propane, and isobutene, all flammable substances. There is also another large tank containing liquid carbon dioxide.

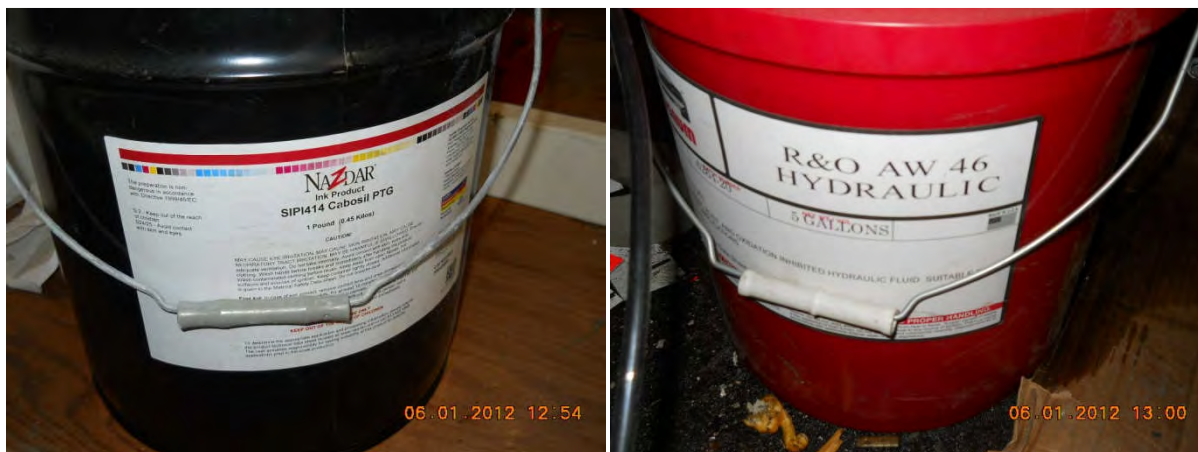
Photo 19. June 1, 2012, Various containers of ink and hydraulic fluid were also indentified in this area as well.

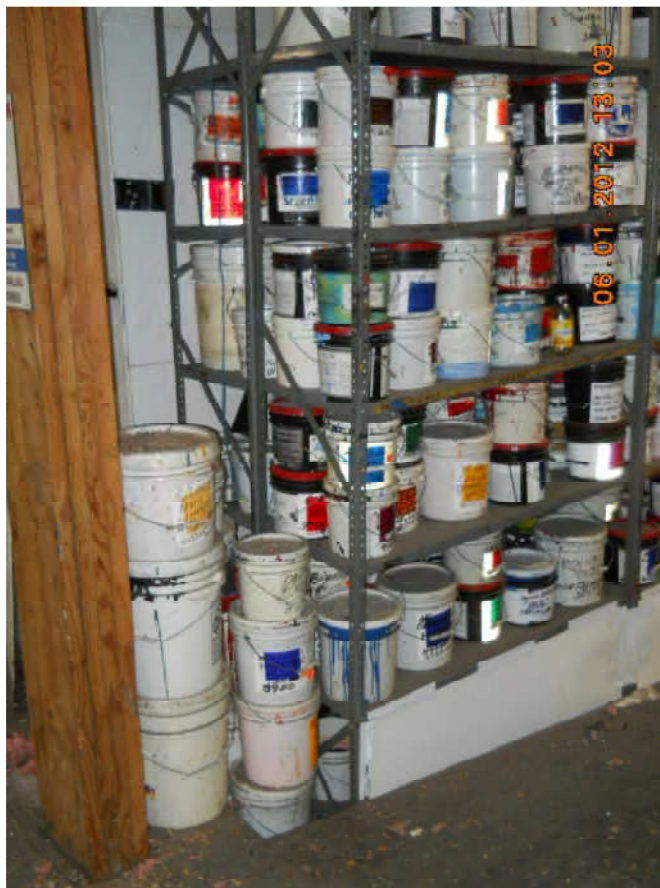
Photo 20. June 1, 2012 – Large UV ink storage area located in the screen making lab, containing a large number of 3M 9700 series UV ink containers.

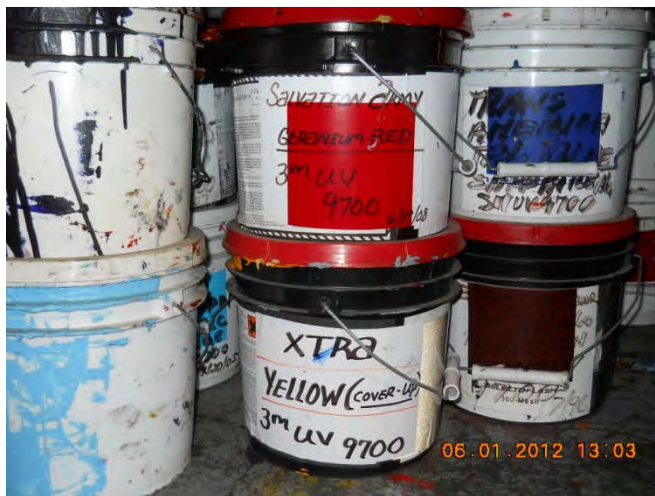
Photo 21. June 1, 2012 - Inks contain various acrylic polymers and various other substances depending on color. Refer to the Removal Assessment-Site Inventory for substances contained in these inks.

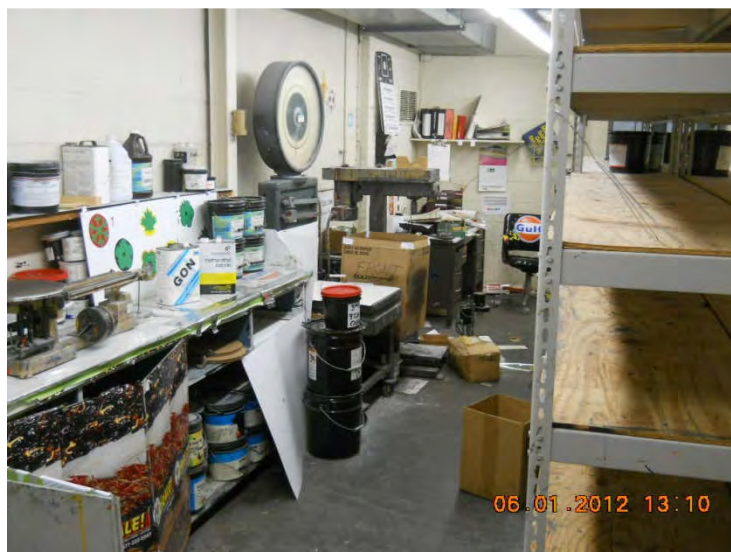
Photo 22. June 1, 2012 – Color mixing lab located in the southern wing of the facility. This room contained more containers of 3M 9700/9800 series UV inks. This area did have a noticable odor. However, there were no readings indicated by the MultiRae.

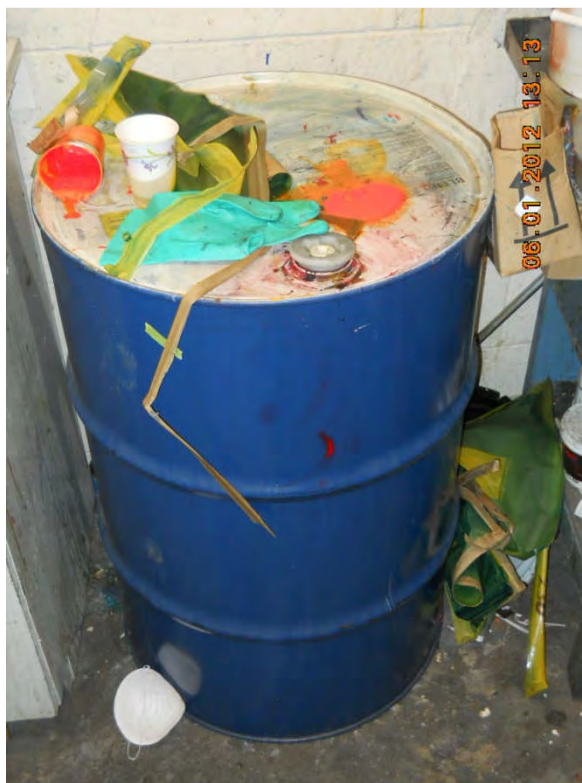
Photo 23. June 1, 2012 – 55-gallon drum with no label, believed to contain the same “Blend Selecto Screen Wash #800” found in the wash station.

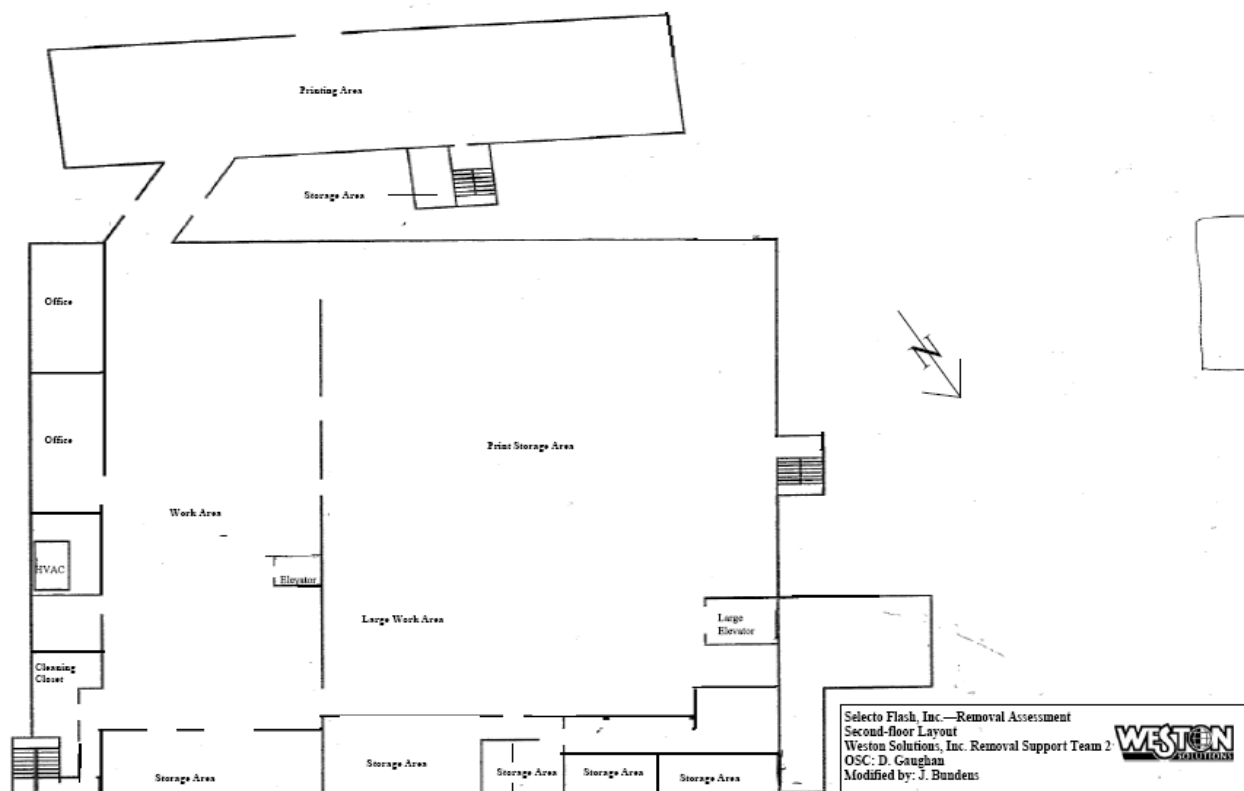
Photo 24. June 1, 2012 – The second-floor of the facility was used for solvent based printing. The northern end contained large working spaces as well as office spaces. The southern wing contained the printing machine where solvent based inks were used.

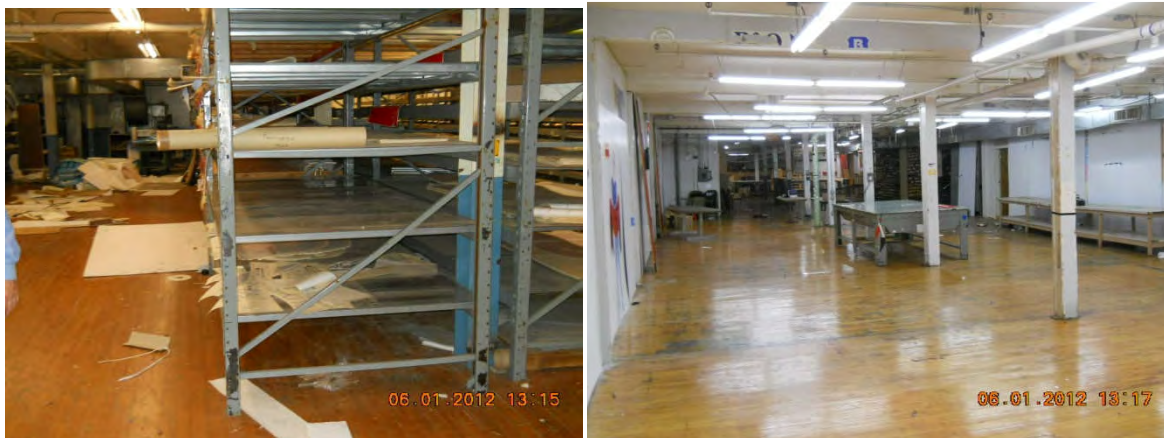
Photo 25. June 1, 2012 - The second-floor also contains shelving units for material storage. Large work spaces allowed for adequate work environment.

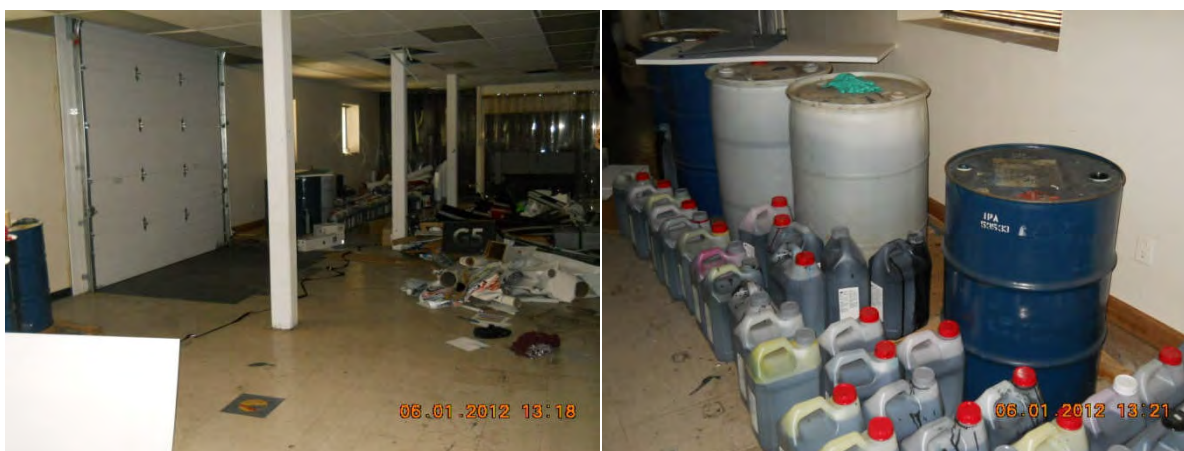
Photo 26. June 1, 2012 – The printing area on the second floor, formerly contained a large industrial printing machine which used solvent based inks. Large numbers of ten-liter containers of solvent based ink were identified. Several 55-gallon drums were identified which are believed to contain “Blend Selecto Screen Wash #800”. Another 55-gallon drum which contained Isopropyl Alcohol was open at the top with a reading of 89.5 ppm as indicated by the MultiRae.

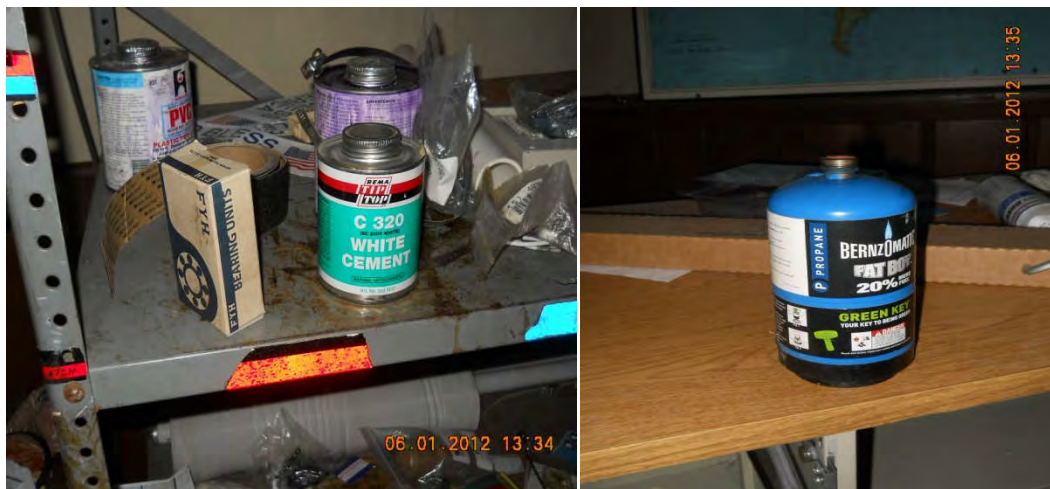
Photo 27. June 1, 2012 – Small storage areas on the northern end of the second floor contained minor areas of concern including poly vinylchloride (PVC) cement and a small cylinder of propane.

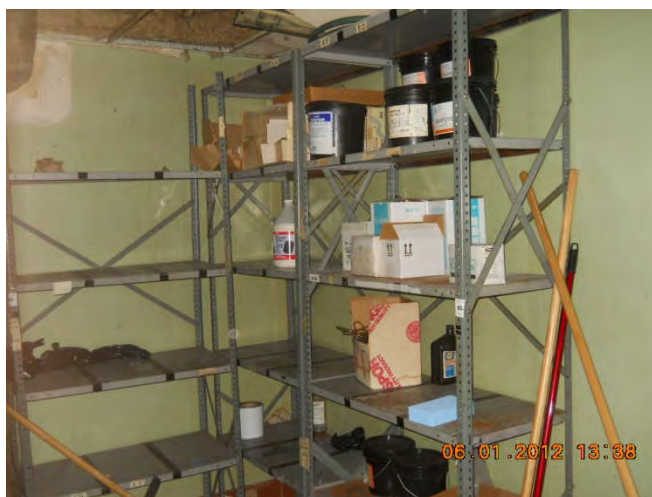
Photo 28. June 1, 2012 – Cleaning closet on the second floor contained various five-gallon buckets and containers believed to contain cleaning solutions. The door was locked so this could not be confirmed.

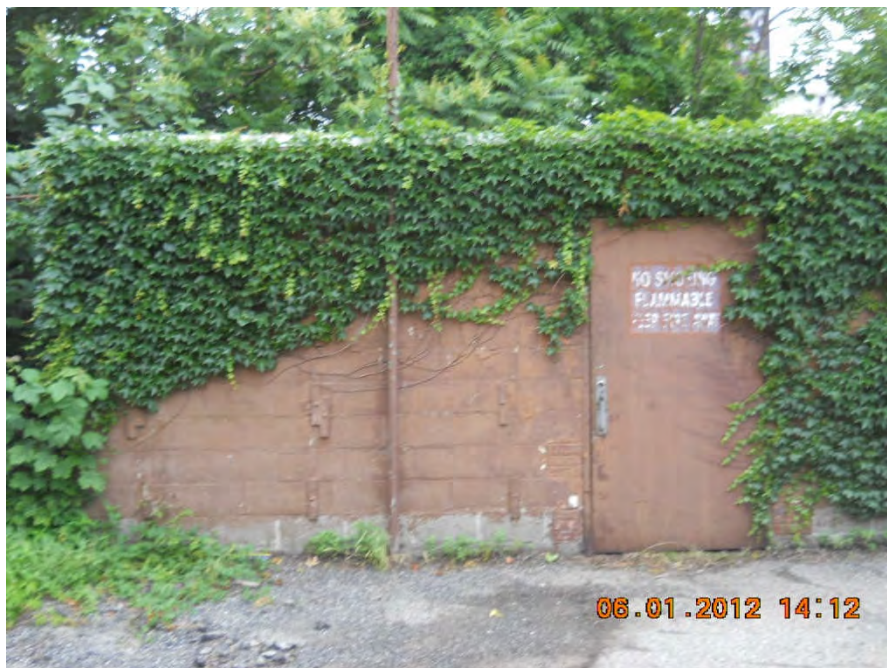
Photo 29. June 1, 2012 - One-story storage building located to the western portion of the Site.

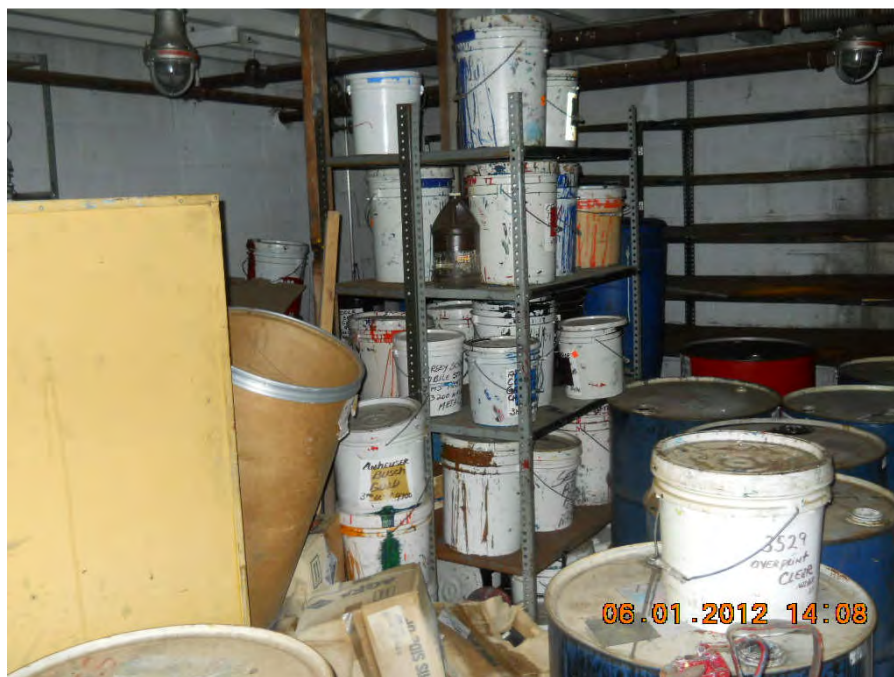
Photo 30. June 1, 2012 – This building contained large numbers of UV and solvent based inks, paint thinners, as well as several 55-gallon drums. RST 2 was not able to fully enter this building due to strong odors. It is assumed that these are similar materials found throughout the rest of the facility. One 55-gallon drum was labeled Ethyl Acetate.

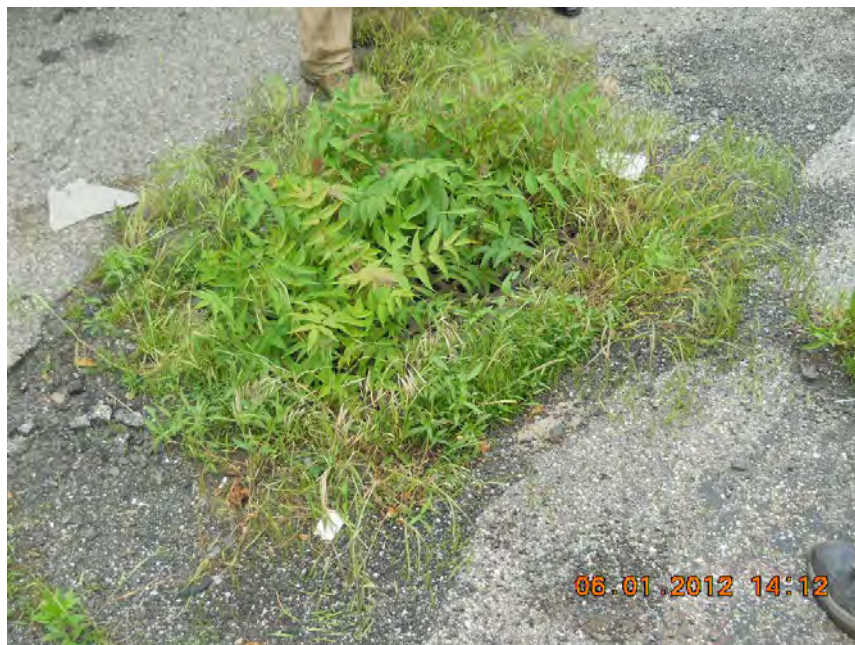
Photo 31. June 1, 2012 – Storm-water drain located in the western parking lot. This is a possible runoff point if there was a potential spill at the Site.

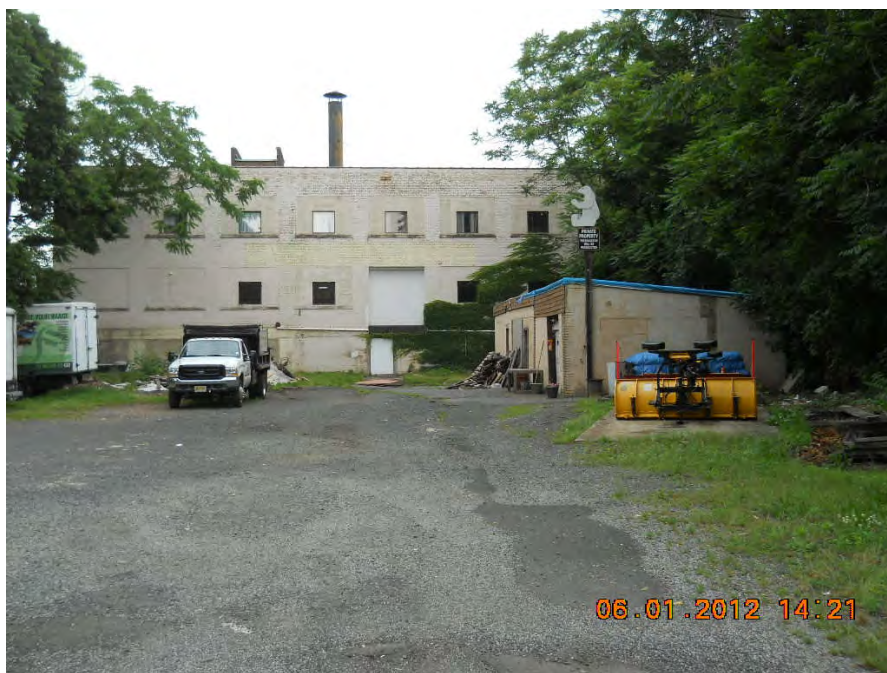
Photo 32. June 1, 2012 – View of the site from the southern unpaved parking lot. This area has a small building which is used for landscaping.

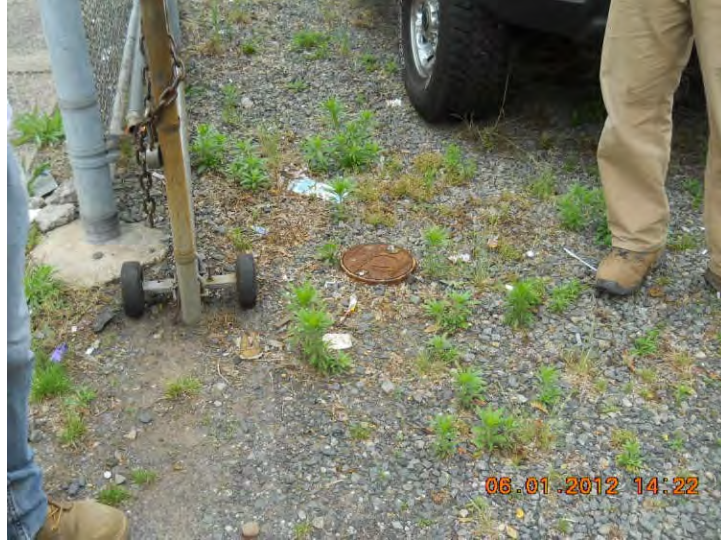
Photo 33. June 1, 2012 –A monitoring well in the unpaved parking lot, previously installed by the Environmental Protection Agency in 2008.
